REPORT NO. NADC-77328-60

6 GALVANIC CORROSION FATIGUE TESTING OF 7075-T6  
ALUMINUM BONDED WITH GRAPHITE-EPOXY COMPOSITE

10 S. R. Brown and J. J. De Luccia  
Aircraft and Crew Systems Technology Directorate  
NAVAL AIR DEVELOPMENT CENTER  
Warminster, Pennsylvania 18974

11 10 JAN 1978

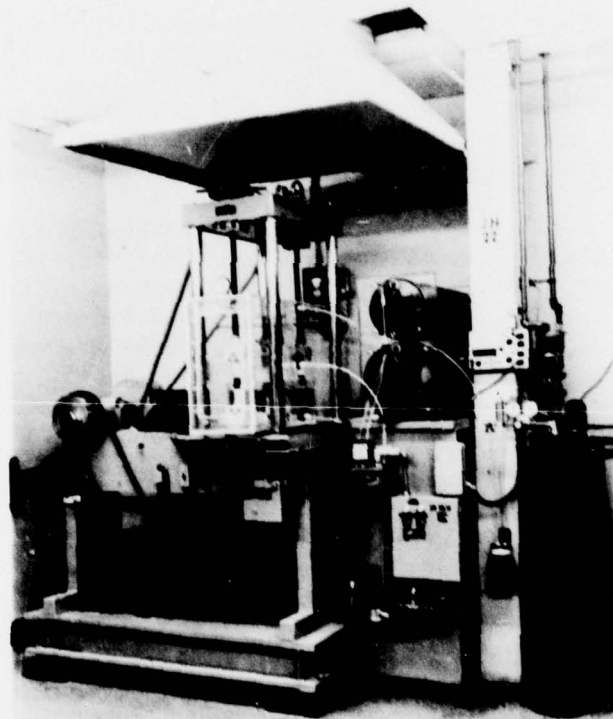
A salt spray chamber was installed on a Krouse direct stress fatigue machine to study graphite-epoxy/metal alloy combinations in a sulfur dioxide-salt spray environment. The fatigue machine, chamber and support equipment are shown in Figure 1.

Figure 1 - Galvanic Corrosion-Fatigue Test Unit

The chamber is 2 ft. high by 1 ft. wide by 3 ft. deep and constructed of 0.5 in. thick acrylic plastic. Removable end panels provide access to the two test stations. An atomizing nozzle and tower in the chamber plus the external humidifying tower and solution reservoirs provide the 5 percent salt fog environment. Sulfur dioxide gas injection equipment includes a flowmeter, solenoid valve, timer and compressed gas storage cylinder.

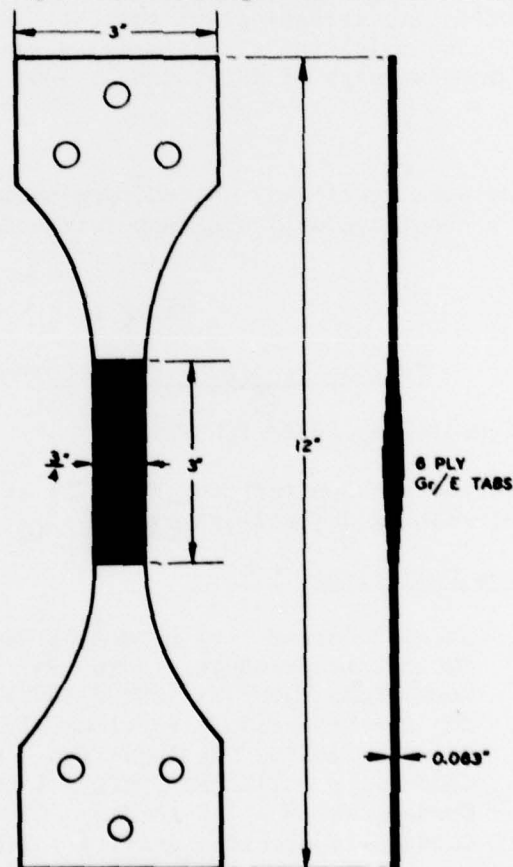
Fatigue specimens were made from 0.063 in. thick 7075-T6 unclad aluminum sheet. Specimens were fabricated with the direction of rolling in the longitudinal direction of the panel so failure would occur in the transverse direction. Graphite-epoxy tabs were laid up using six layers of Hercules "MagnaMite" 3501/AS1-6 graphite prepreg and "stepped" to minimize stress concentrations at the bond junction to the aluminum specimens. Hysol EA9309 was used to adhesively bond graphite-epoxy tabs to aluminum fatigue specimens as shown in Figure 2. Bonding conditions were 117 kPa (17 psi) in an autoclave at room temperature for 24 hours. A room temperature cure epoxy was used to avoid strength level changes of the aluminum.

Figure 2 - Galvanic Corrosion Fatigue Specimen Graphite-Epoxy Bonded to Aluminum

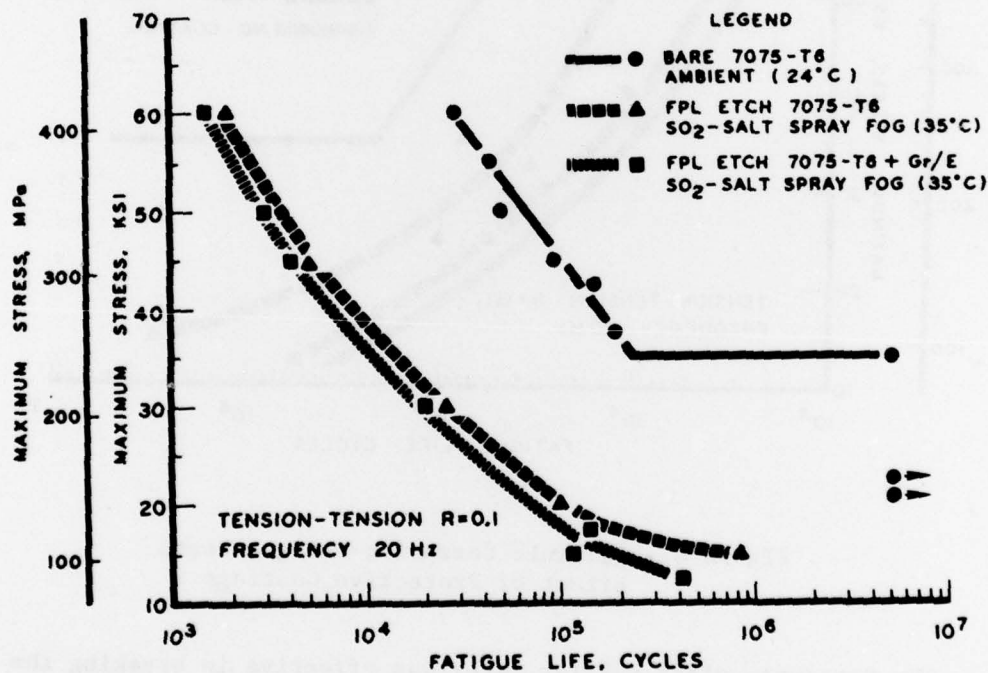
Fatigue life of bare 7075-T6 was reduced from 150,000 cycles at the 40 ksi stress under ambient conditions to 8,400 cycles (FPL etched) under the same stress when exposed to sulfur dioxide-salt spray as given in Table I. A further reduction to 6,400 cycles was experienced with bonded graphite-epoxy tabs due to the galvanic coupling effect. This is shown in Figure 3.

Figure 3 - Galvanic Corrosion Fatigue Tests Without Protective Coatings

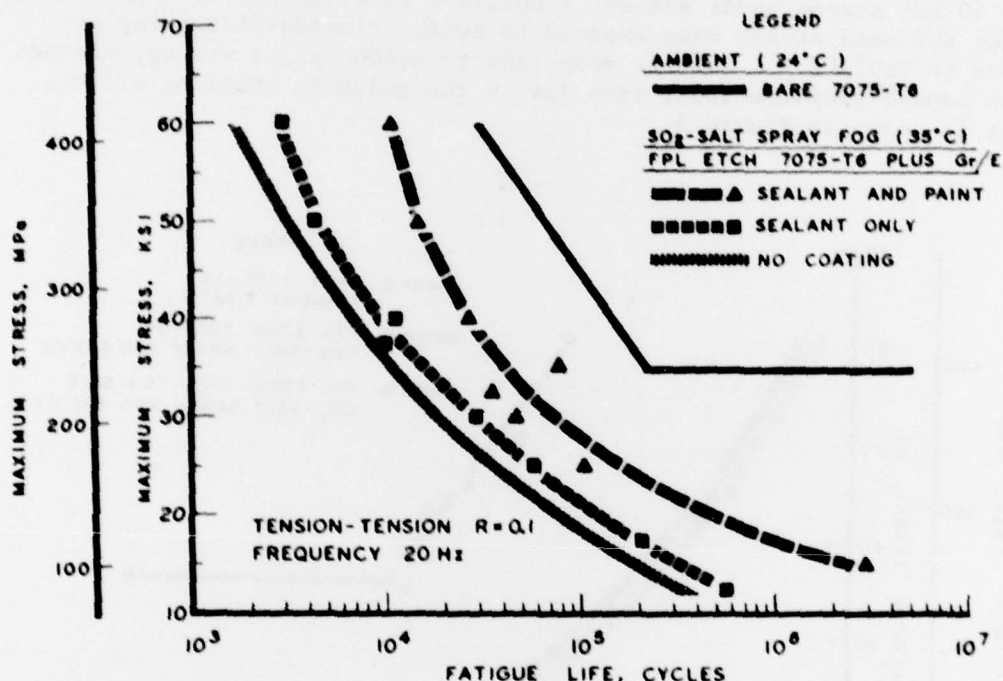
A degree of baseline fatigue life (bare 7075-T6 at ambient conditions) was recovered by applying protective coatings of polysulfide sealant to the coupled edges and overcoating with inhibited epoxy primer-polyurethane topcoat. This protective scheme provided an additional 20,000 cycles of fatigue life at 40 ksi over the uncoated condition as shown by the "sealant and paint" curve in Figure 4.

Figure 4 - Galvanic Corrosion-Fatigue Tests  
Effect of Protective Coatings

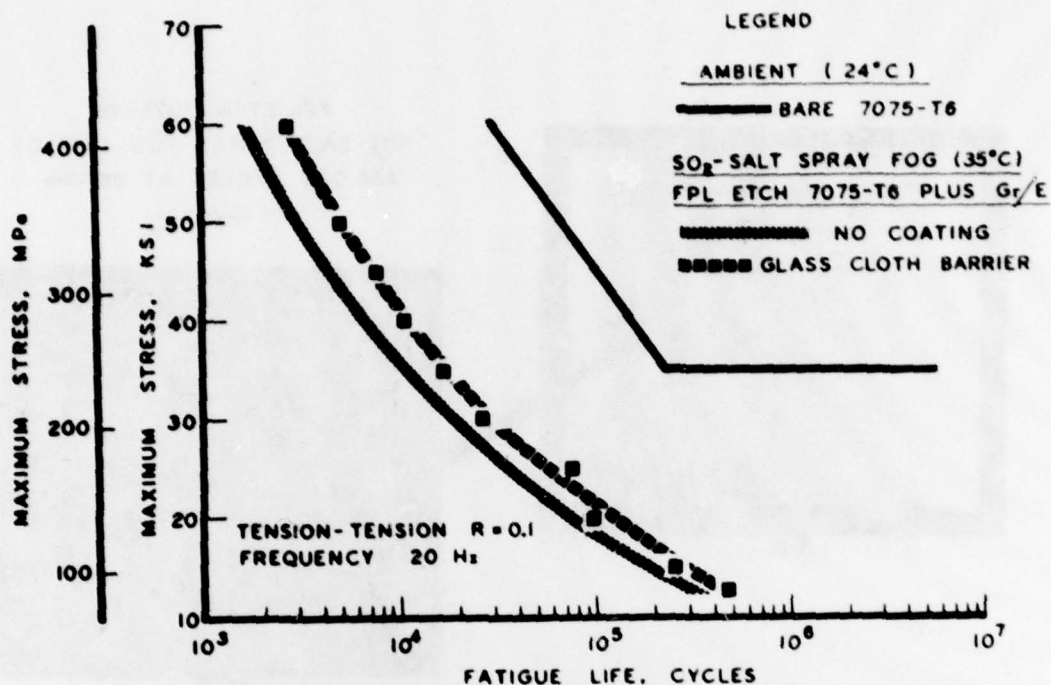
The Scotchply glass barrier layer was effective in breaking the galvanic couple between the graphite-epoxy tabs and aluminum fatigue specimens. Resistance across regular adhesively bonded graphite-epoxy to aluminum was measured as 60-100 ohms. With the glass barrier cloth acting as an insulator, resistance was 100 megaohms, a  $10^6$  - fold increase. The S-N curve for specimens with the glass cloth barrier bonded between the graphite-epoxy and aluminum, exposed to the corrosive environment, is shown in Figure 5.

Figure 5 - Galvanic Corrosion Fatigue Tests  
with Glass Cloth Barrier

It should be noted that the glass cloth restored fatigue life to the aluminum to the same extent as the use of sealants. In both cases, the galvanic circuit between the aluminum and the composite is eliminated.

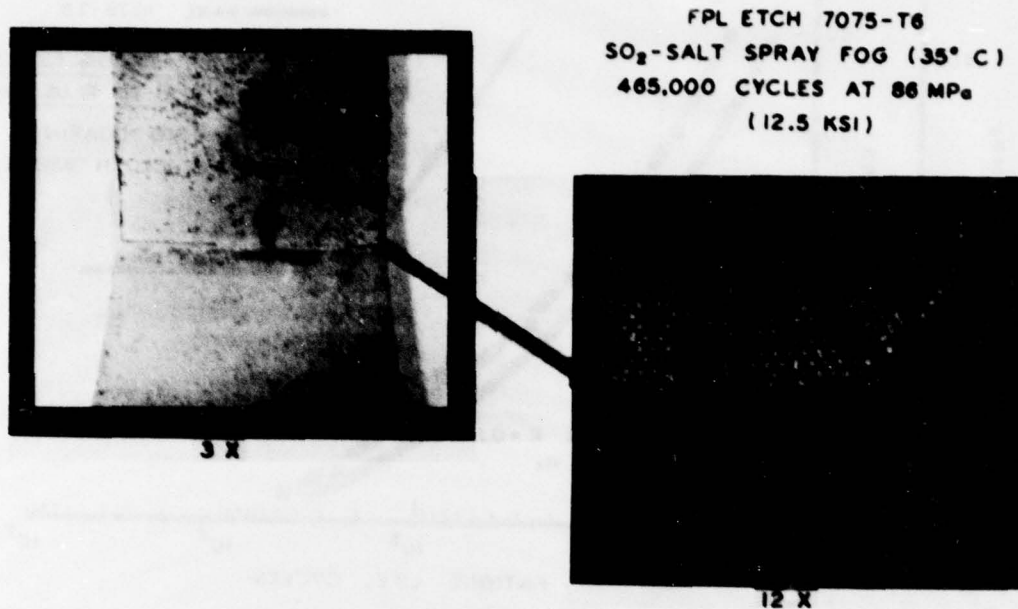
Corrosion of the 7075-T6 aluminum in the proximity of the graphite-epoxy composite is shown in the Figure 6 macrophotographs. Pitting is most severe on the panel edge and at the aluminum/graphite-epoxy tab boundary. The basket weave pattern in the retained adhesive layer is simply an impression of the peel-ply from the graphite prepreg after removal of the graphite-epoxy tab.

Figure 6 - Corrosion of 7075-T6 Fatigue Specimens  
Evident After Removal of Graphite-Epoxy Composite Tab

Figure 7 is a SEM study of a corroded aluminum surface area from Figure 6. Intergranular corrosion is quite evident in the magnified views and was accelerated by the proximity of the graphite-epoxy to the aluminum.

The photomicrographs of Figure 8 are of the same specimens as shown in Figures 6 and 7, but were taken at the opposite end of the graphite-epoxy tab where the fatigue failure occurred. The cross-section was made across a deep pit that developed in the aluminum at the end of the graphite-epoxy tab. This pit, or a similar pit, served to initiate fatigue failure of their specimen. Mount supports shown in the upper portions of the Figure 8 (a) and (b) are not part of the specimen.

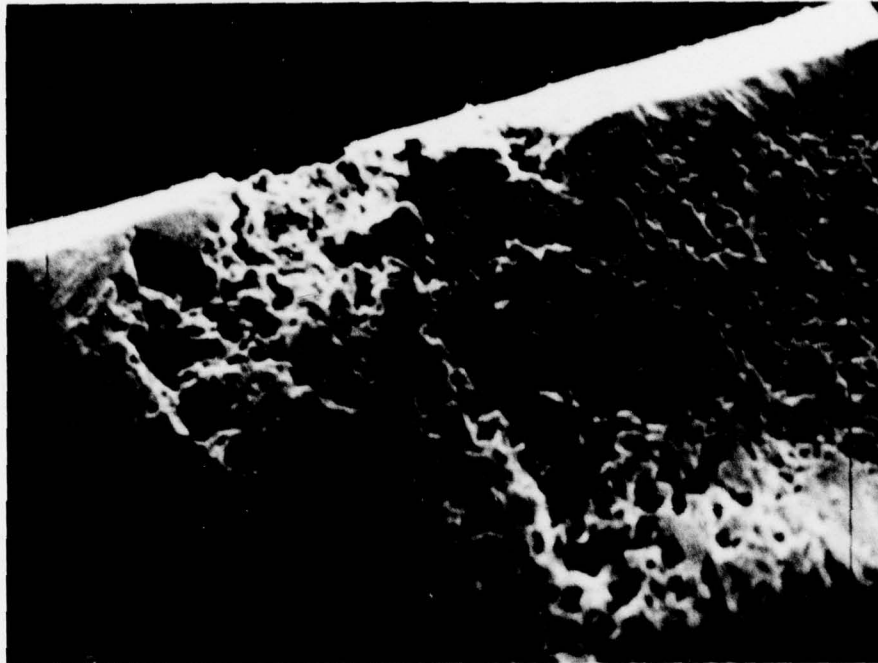
Fatigue failures originated from pitting sites at graphite-epoxy and aluminum intersections. Figure 9 shows an isometric view of an aluminum specimen in the vicinity where the graphite-epoxy tab was attached. Note the severe pitting of the aluminum. These pits act to concentrate stress and initiate fatigue cracking.

Figure 9 - Scanning Electron Micrograph of Pitting Corrosion in 7075-T6 Aluminum at Graphite-Epoxy/Aluminum Interface (Original Magnification - 100X)

Figures 9 and 10 were photographically enlarged about 25 percent  
over original magnification.
